DESCRIPTION OF WORK

Historic Property Descriptions

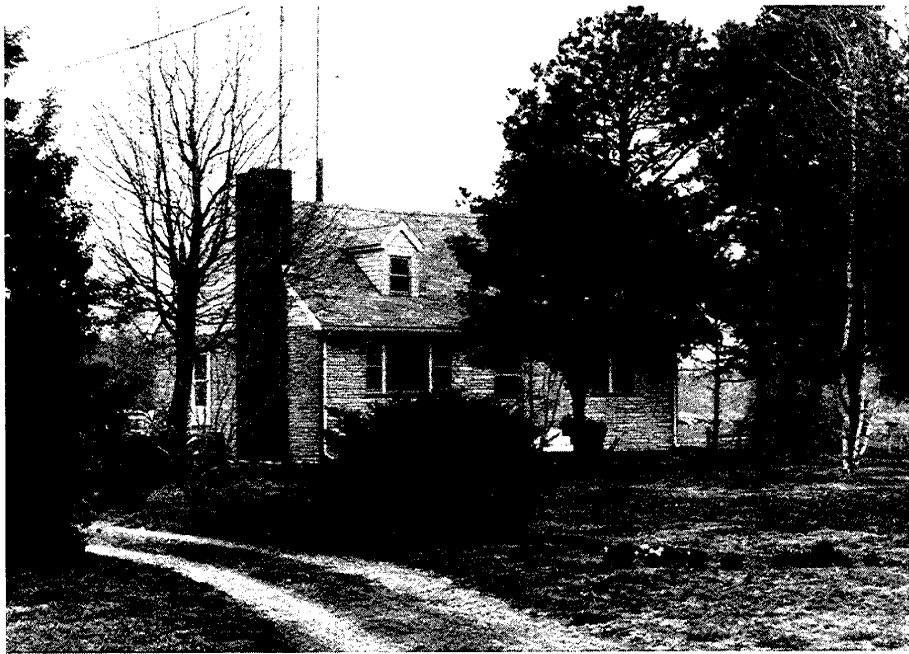
This small agricultural complex is positioned on the north side of Route 404, just east of the Maryland State line. The house is a one and one-half story, rectangular plan cottage, three bays wide and two bays deep, with a gable roof. The entrance is centrally placed in the south facade facing the road. It is flanked by modern, picture windows. There are two, gable roofed dormers in the upper story of the front facade. The gable roof is sheathed in composition shingles. The house appears to be constructed of concrete block with a fake stone veneer on the front facade. A modern, exterior, brick chimney is placed in the center of the west facade.

PLATE 6a: CRS S-8397
View of south and west facades of house, looking northeast.
Note modern windows and exterior chimney stack.

This property is not an eligible complex. Although the barn appears to be historic, the house seems to date to post 1945. A structure, that may have been a previous residence, is indicated at this site on a 1913 map of the project area (Wilmer Atkinson 1913, Appendix C). The current house possesses little architectural significance, and the barn does not stand on its own as an important cultural resource.

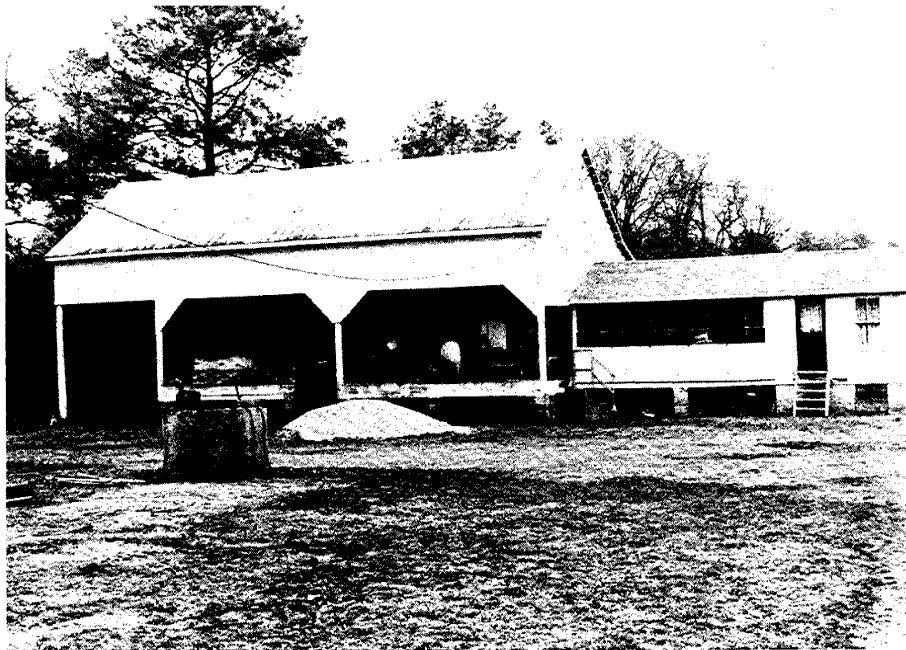
Located on this same property, just west of the house, is a frame barn. The barn has a gable roof and three bays opening on the south facade facing the road. The building is clad in horizontal, wood siding and is raised on concrete block piers. This part of the barn appears to be used for machinery storage. A one story, gable roofed addition is attached on the east

PLATE 6b: CRS S-8397
View of barn complex to the west of the house, looking north.
Note frame construction.

facade. This section appears to have been used for some type of office. It is also raised on concrete block piers and is clad in the same horizontal boarding. An entrance into the building is present on the south facade.

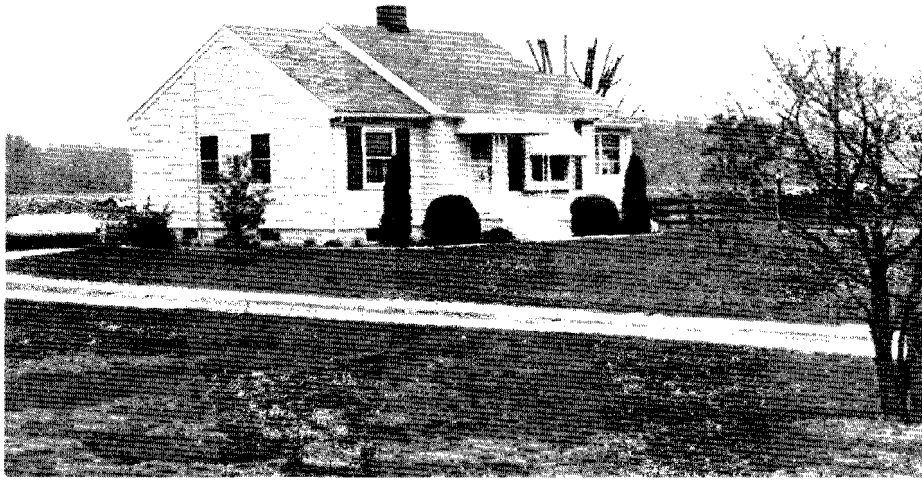
This house is located on the north side of Route 404, east of CRS S-8397. The house is a one story, concrete block cottage with a gable roof. The building is four bays wide and one bay deep with a center, brick chimney. It has modern windows with louvered shutters. The dwelling is clad in yellow, aluminum siding. The house appears to date to post 1945, and possesses little architectural significance, making it ineligible for evaluation based on National Register Criteria.

PLATE 7: CRS S-8398
View of south and west facades of house.

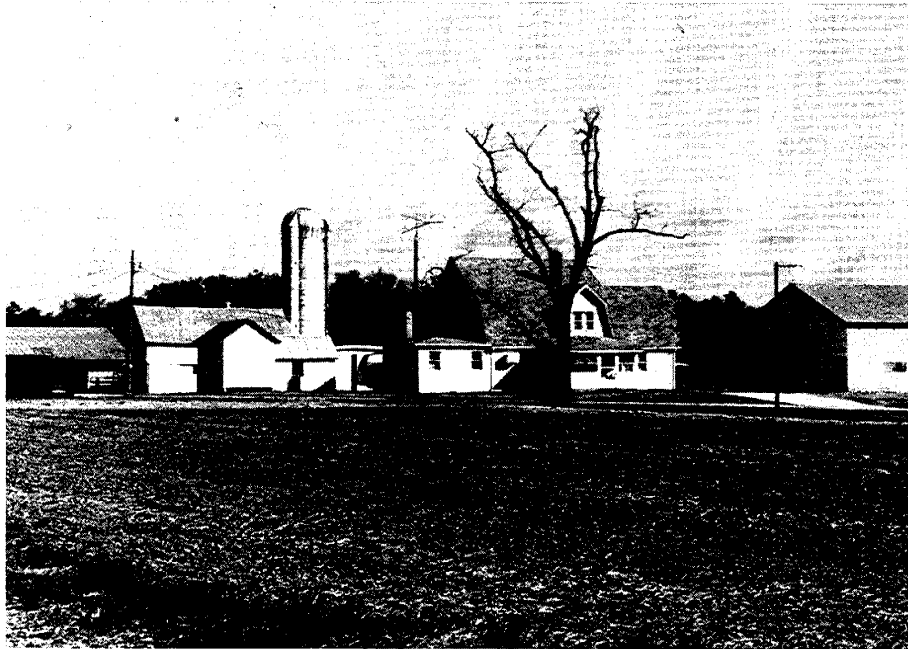
This property does not appear to be eligible. The original nineteenth century I-house has been heavily altered over the years with several additions, and changes in the roof line and fenestration. The agricultural outbuildings do not appear to be historic, and most likely have replaced the original farm structures. There are several other agricultural complexes in the corridor that retain both their historic buildings and function.

PLATE 9: CRS S-1788
View of house and agricultural outbuildings, looking north.

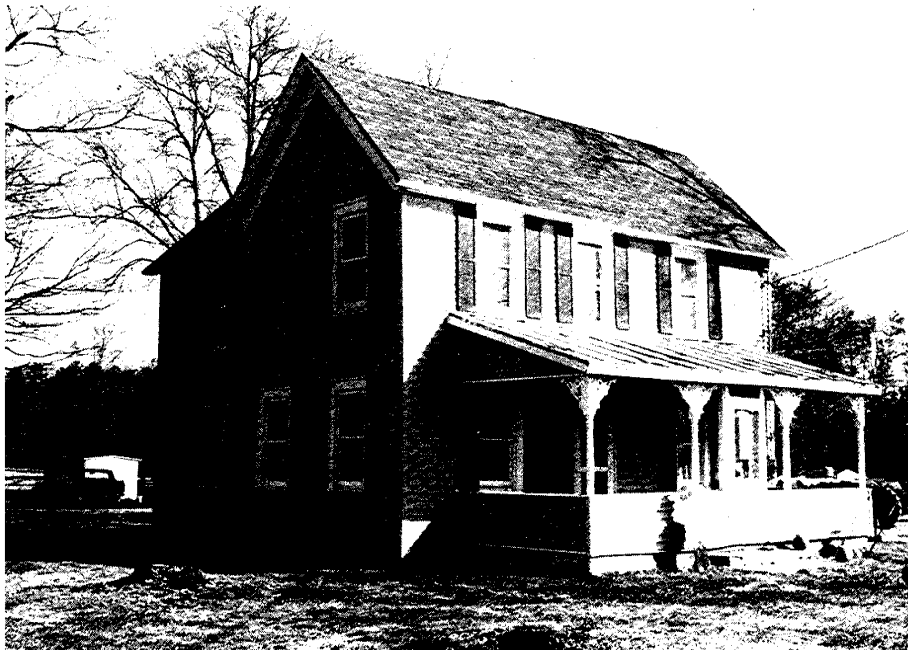
PLATE 10: CRS S-1797
View of south and west facades of house, looking southwest.
Note Victorian detailing on porch supports.

This nineteenth century complex appears to be eligible as a contributing part of the proposed, Three Bay, I-House, Multiple Property Submission. The house retains its original form and symmetrical fenestration, and is in excellent condition. Several outbuildings contribute to the overall integrity of the property. The property is significant under the priority theme of Agriculture (Ames et. al. 1989:79, 83).

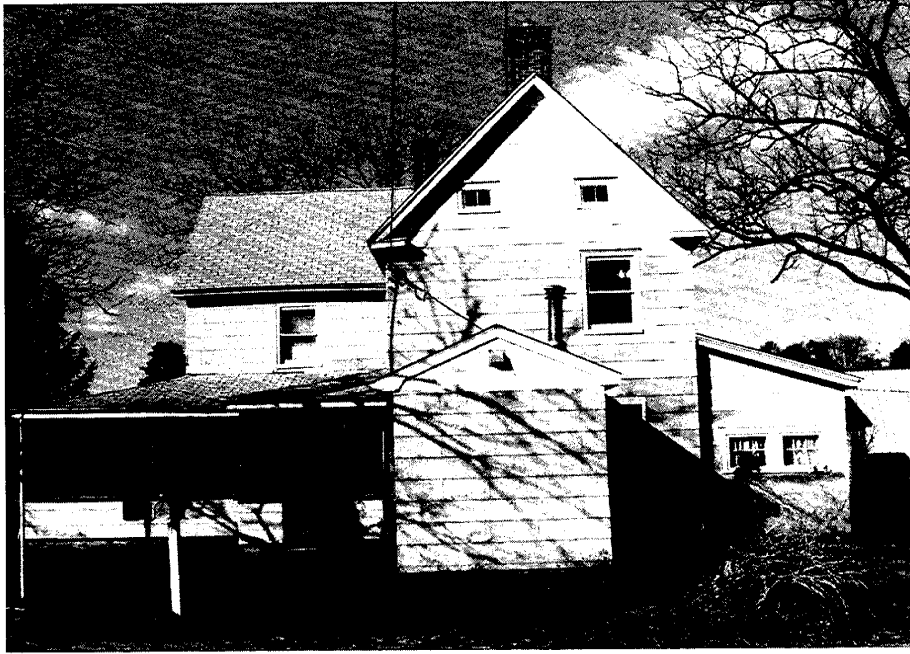
PLATE 11: CRS S-8399
View of west facade of house, looking west.
Note additions on east and north facades as well as modern window replacements.

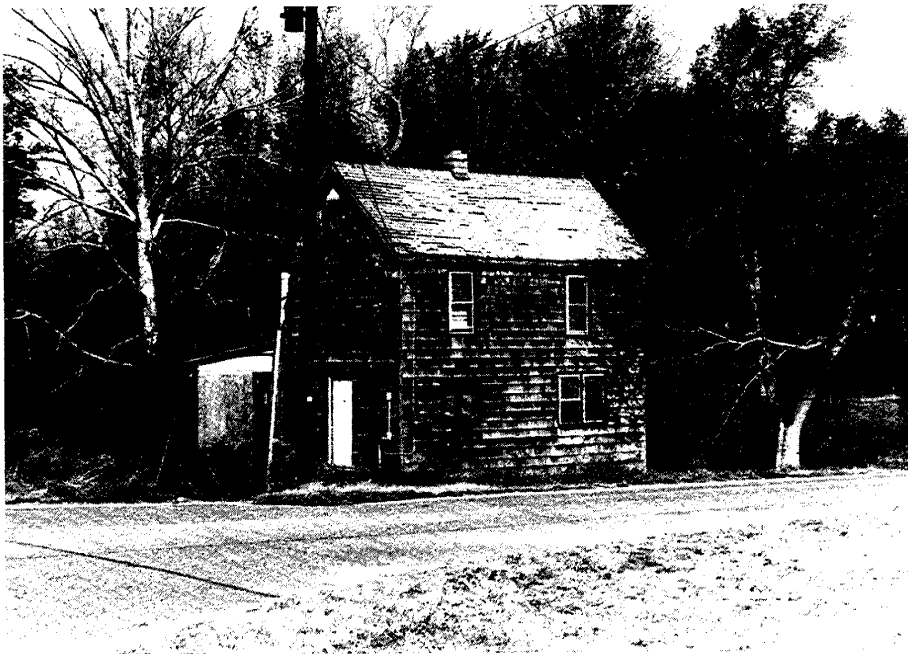
PLATE 12: CRS S-1795
View of east and south facades of house, looking northwest.
Note window replacements, door insertion, and rear addition.

This nineteenth century house is not eligible due to alterations that have compromised the integrity of the structure. The original window and door placement in the front or north facade is no longer visible due to a one story addition across the building. A wraparound, screened in porch and changes in fenestration also detract from the original symmetry of the house. Throughout the corridor, there are other examples of I-houses that are in better condition and remain true to their original form.

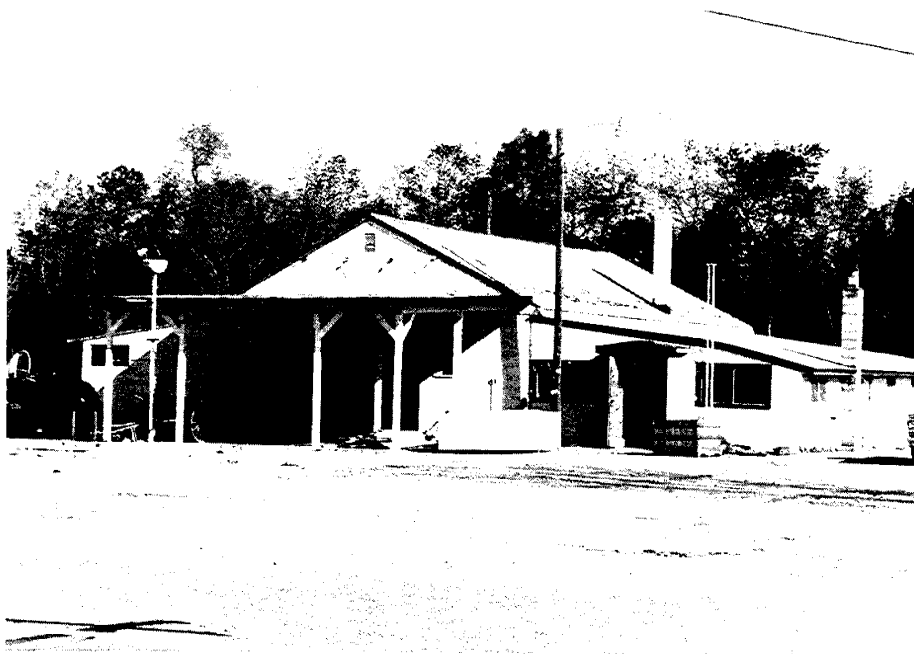
PLATE 13: CRS S-8401
View of south and east facades of garage. Note shed roofed porch on south facade.

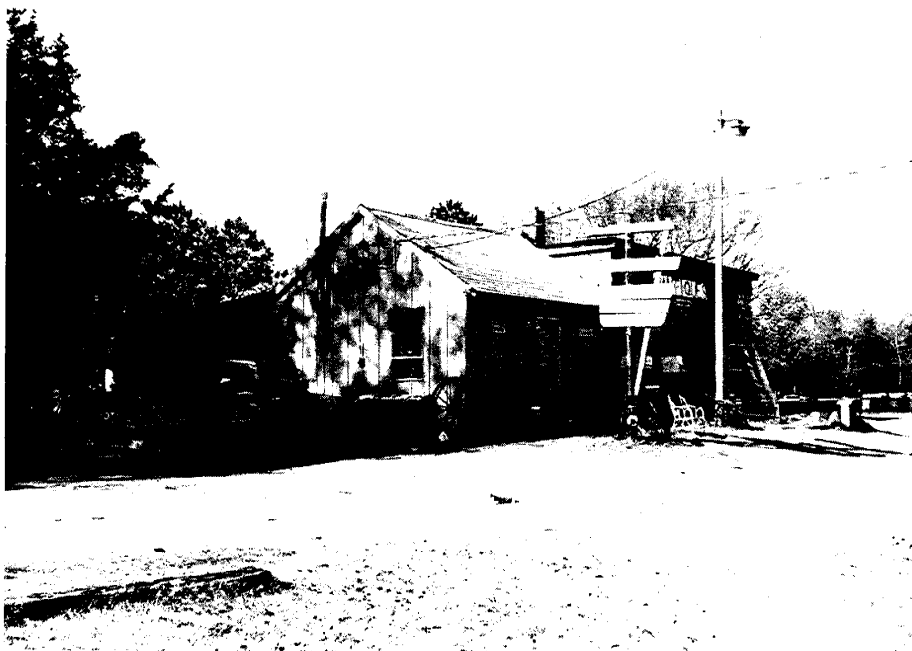
A one story, modern, concrete block section has been built on the west facade, completely obscuring the original facade of the older structure. Part of the front or north facade is covered in composition shingle siding. There is a modern door and a bay window asymmetrically placed in the facade. There are two, casement type windows symmetrically placed in the west facade. A brick chimney is located at the juncture between the two sections.

PLATE 14: CRS S-8400
View of north and east facades of altered dwelling, looking southwest.
Note window replacements, siding, and addition on west.

This property is not eligible due to many alterations. The concrete block addition overpowers the smaller, frame section and compromises the integrity of the house. Changes in the fenestration and the application of board and batten siding also detract from building. There are other examples of Commercial Roadside architecture in the project corridor as well as several surviving Chesapeake Bay Vernacular houses that are in better condition and remain true to their original form.

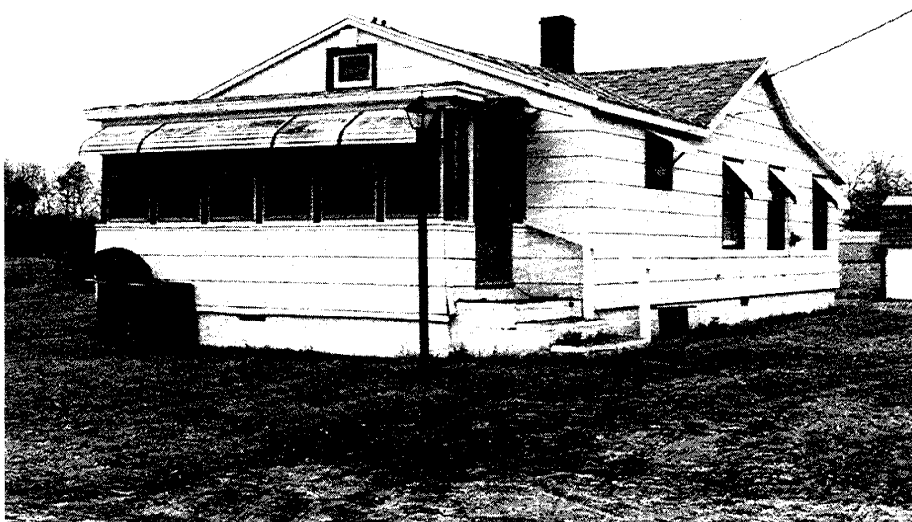
This dwelling complex sits on the north side of Route 404, east of the intersection with Road 578. The house is a one story, cross-plan cottage. Raised on a concrete foundation, this dwelling is clad in composition shingle siding. An enclosed, flat roofed porch is located on the west facade. There are entrances on the west, north, and east facades. The windows are a combination of single pane awning openings and six over six, double hung. A brick chimney is centrally placed at the cross gable.

PLATE 15a: CRS S-8402
View of main facade of dwelling, looking northeast.
Note altered windows and enclosed modern porch.

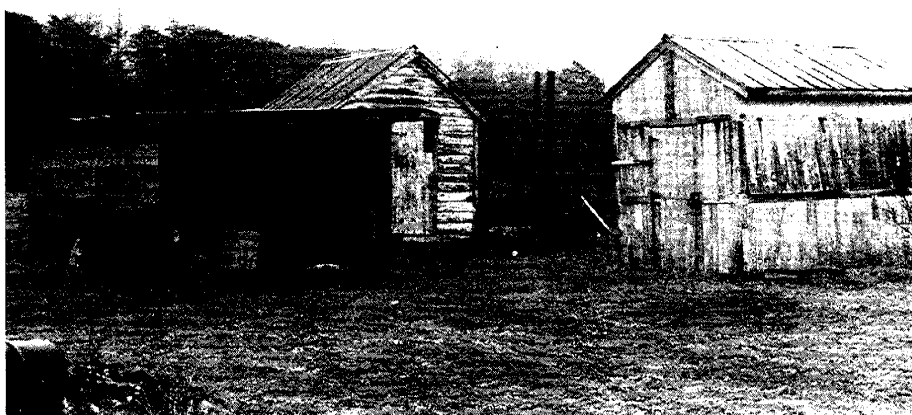
PLATE 15b: CRS S-8402
View of frame outbuildings to rear of house, looking north.

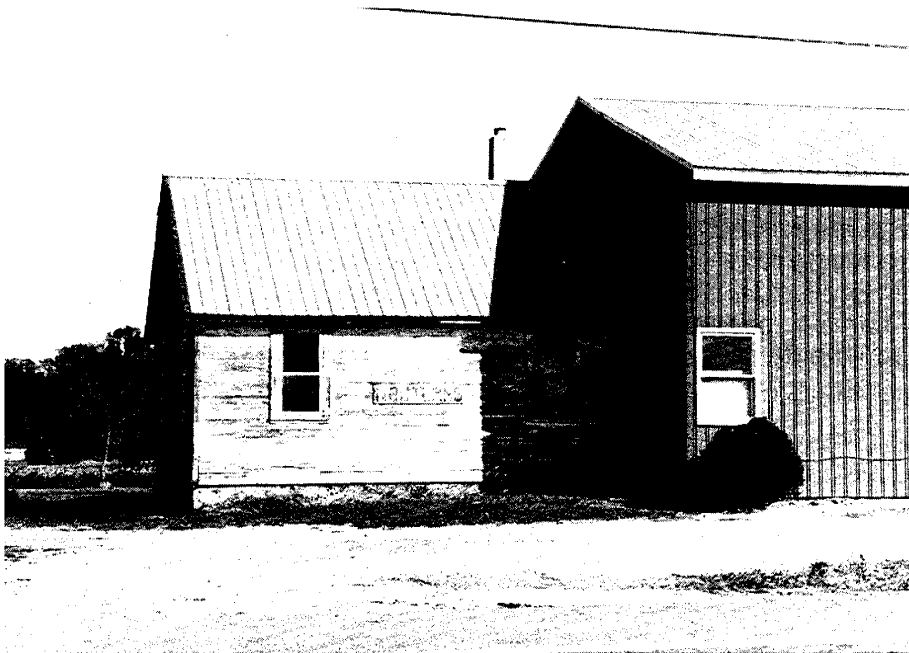
PLATE 16: CRS S-8403
View of south and west facades of commercial building.
Note obtrusive addition on east facade.

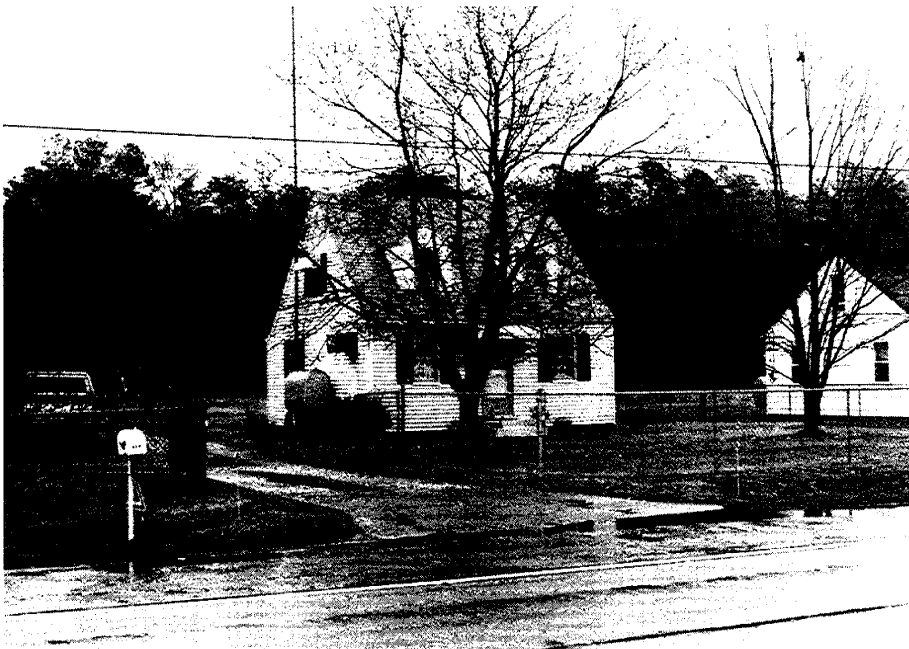
PLATE 17: CRS S-8404
View of south and west facades of house, looking northeast.

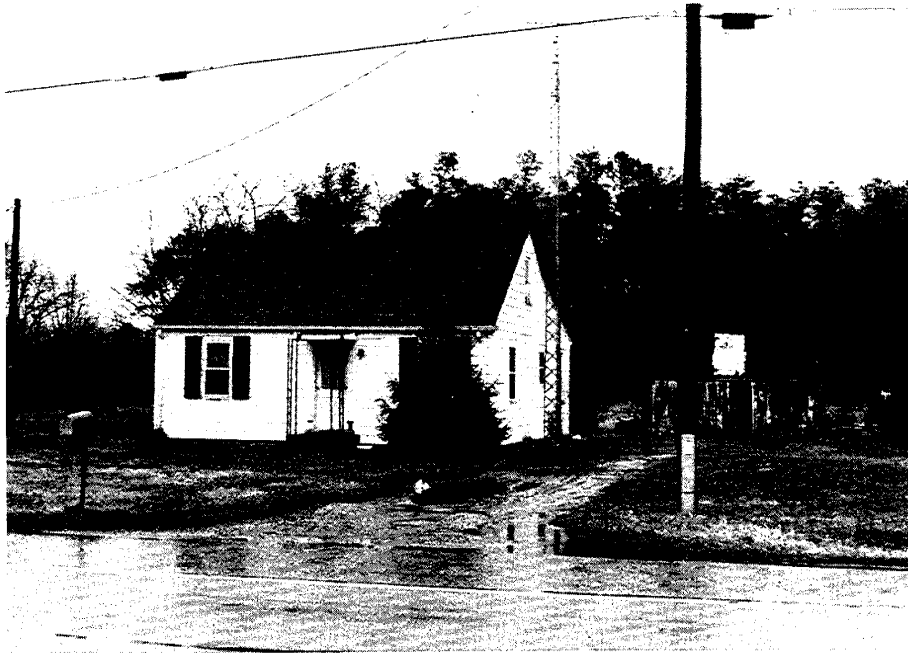
This one and one-half story, rectangular plan cottage sits on the north side of Route 404. The house is four bays wide and two bays deep with a gable roof. A projecting, gable roofed, screened in porch is present in the middle of the front facade. The windows are modern, six over six and double hung. The house rests on a concrete foundation and is clad in wood, shake shingle siding. An interior, brick chimney is placed slightly off center along the ridge of the roof. There is a one car, gable roofed garage at the rear of the property.

This house appears to date to the 1930s or 1940s, and lacks individual architectural significance. In accordance with guidance from the BAHP, these buildings do not form a preservation priority within the project corridor (Personal Communication with Steve DelSordo May 1991). The house is not eligible.

PLATE 18: CRS S-8405
View of south and east facades of house, looking north.
Note frame garage to rear of house.

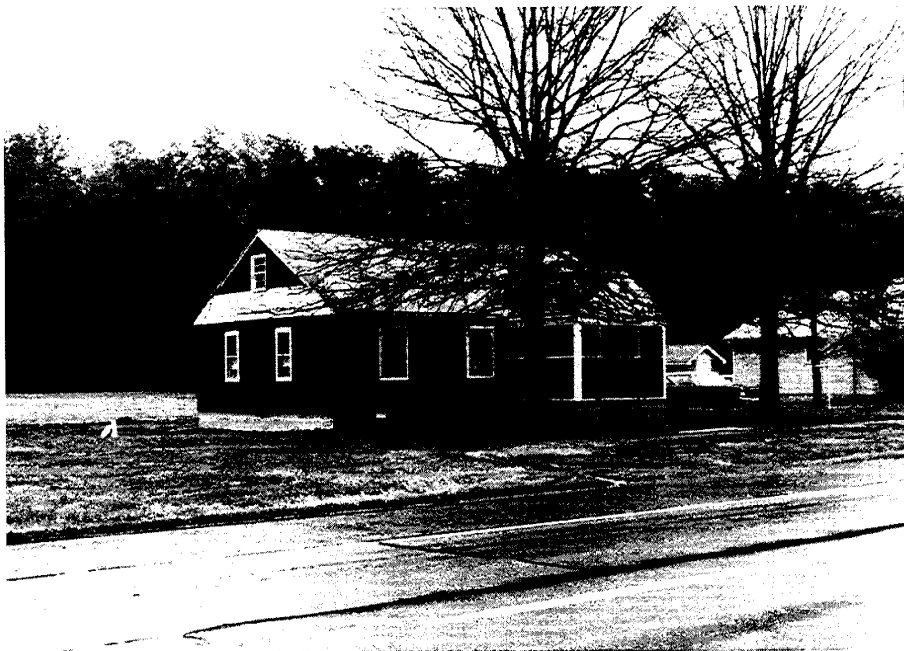
PLATE 19: CRS S-8406
View of south and west facades of house, looking northeast.

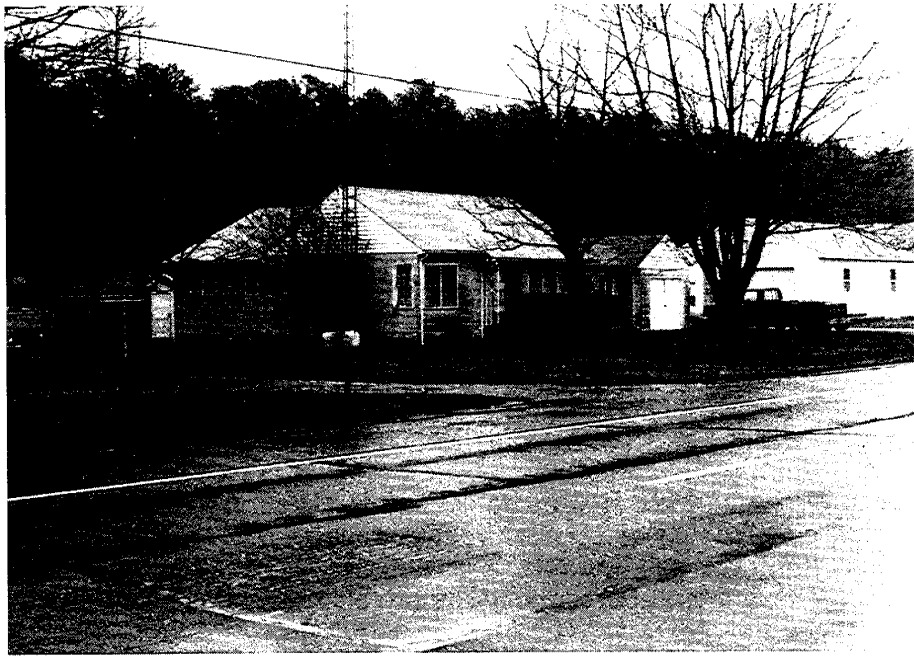
PLATE 20: CRS S-8407
View of south and west facades of house, looking northeast.

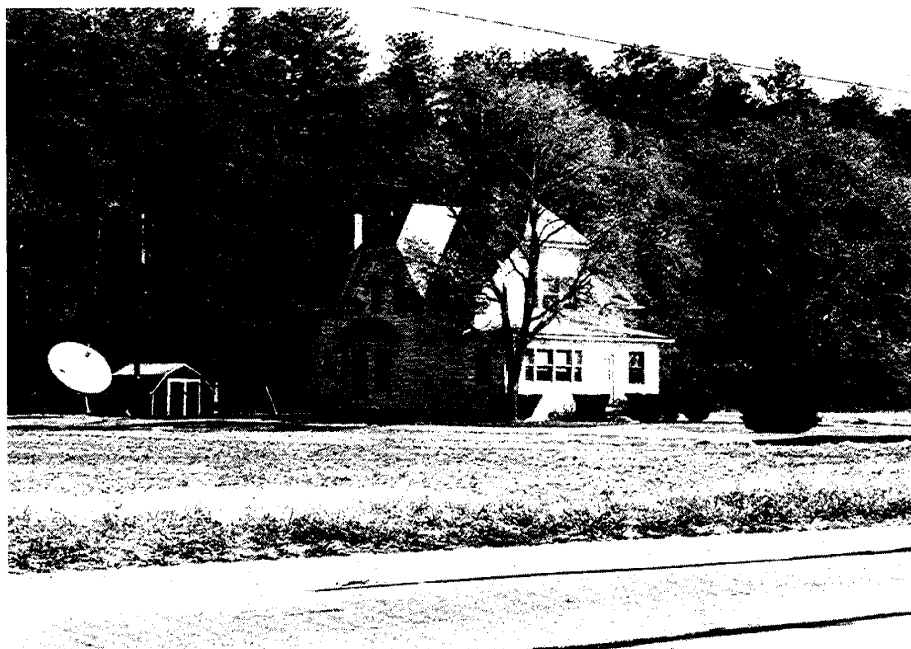
This house appears to date to the early twentieth century and is an individually eligible property. It is the only house of its kind within the project corridor. Its clipped gable roof line with a wooden, boxed cornice is highly unusual and reminiscent of the Dutch Colonial Revival style popular in the 1920s and 1930s. Similar houses can be found in Gowans 1987, which details suburban domestic architecture (Gowans 1987). The building is architecturally significant under the historic theme of Suburbanization: 1880-1940 (Herman et. al. 1989).

PLATE 21: CRS S-8408
View of south and west facades of house, looking northeast.
Note unusual clipped cross-gable roof line.

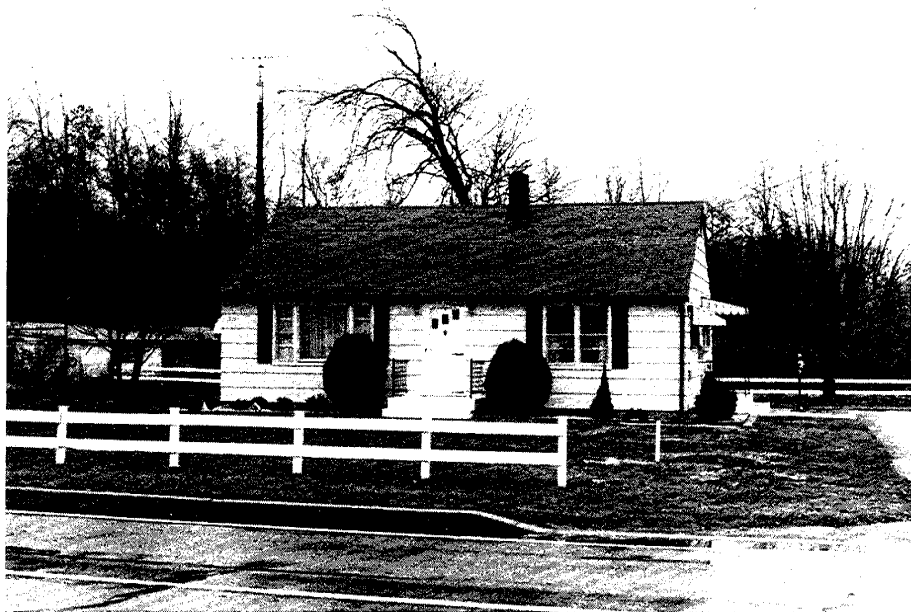
PLATE 24: CRS S-8409
View of north facade of house, looking south.

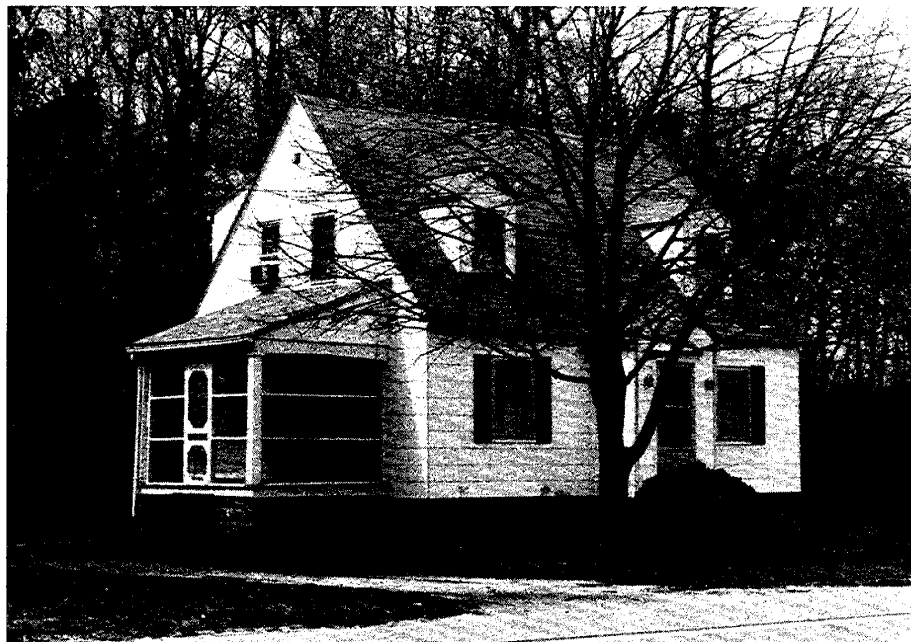
PLATE 25: CRS S-8410
View of north and east facades of house, looking southwest.

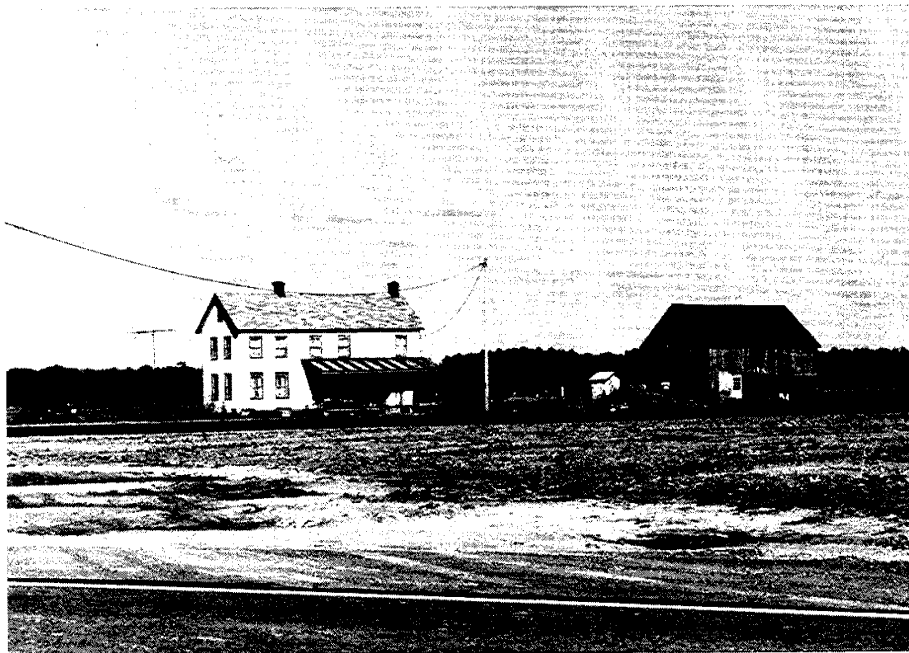
PLATE 26: CRS S-8411
View of south and west facades of house, looking north.
Note large frame barn and outhouse to east of house.
Note also unusual fenestration of house.

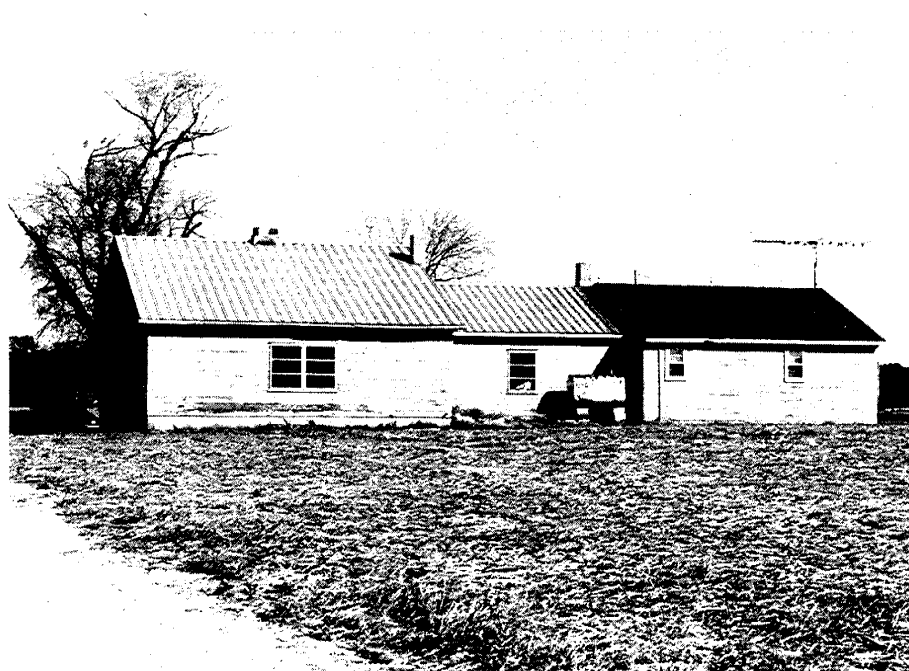
PLATE 27: CRS S-346
View of outbuildings of Dutch Ayr Farm, looking northeast.
Note modern windows and construction.

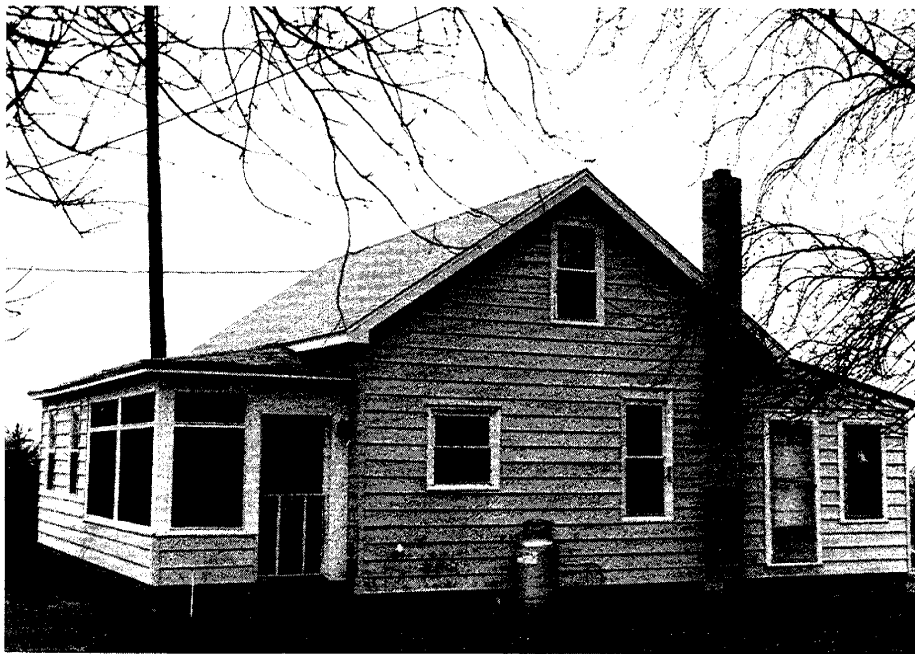
PLATE 28: CRS S-1757
View of west facade of house, looking east.
Note altered fenestration and porch additions.

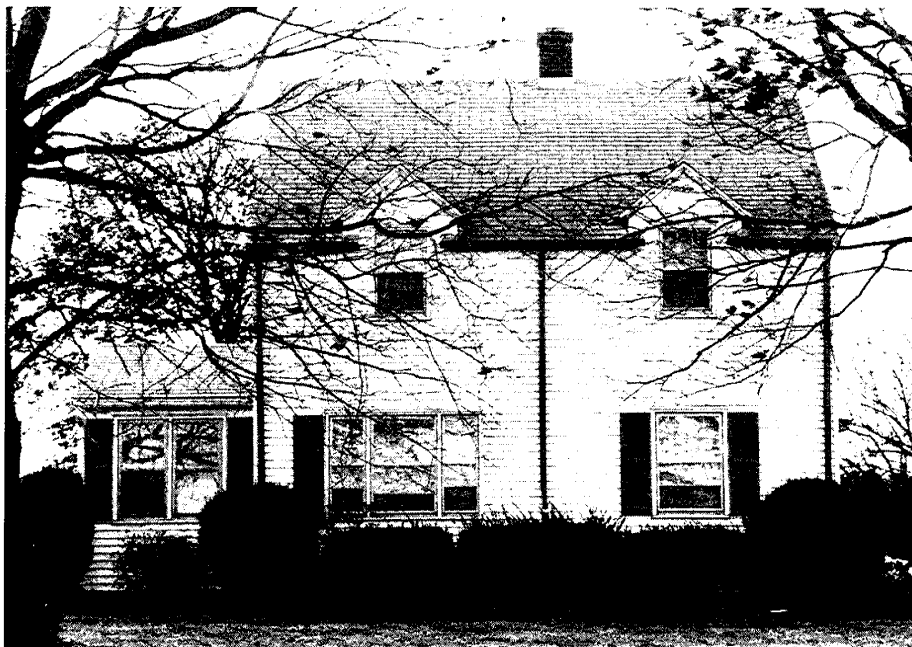
PLATE 29: CRS S-1758
View of north facade of house, looking south.
Note altered fenestration including dormers.

This heavily altered house is not eligible due to modern remodeling. The original fenestration is unclear due to the insertion of picture windows and the removal of a door from the main facade. Dormer windows in the second story were also added, as was a one story addition on the east facade. This house no longer resembles its original I-house form. There are better examples of the I-house found throughout the project corridor with greater integrity.

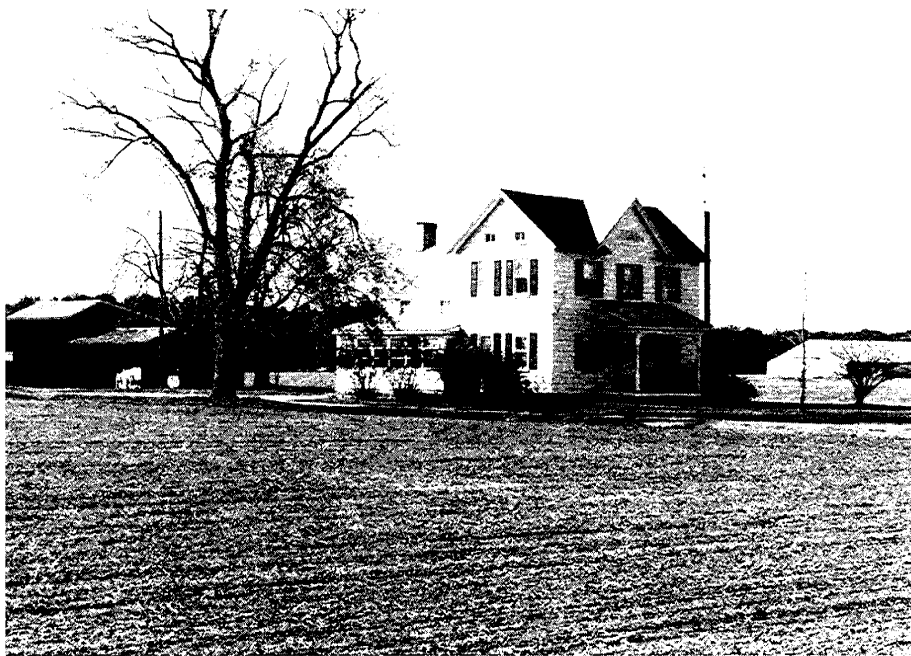
This nineteenth century complex appears to be eligible as part of the proposed, Three Bay, I-House, Multiple Property Submission. The house is in excellent condition and retains its basic form and fenestration pattern. The property is still used for farming and has several agricultural related outbuildings. The property is significant under the priority theme of Agriculture (Ames et. al. 1989:79, 83).

PLATE 30: CRS S-1759
View of north and east facades of house, looking southwest. Note frame vehicle storage structures to rear of house. Note intact fenestration and Victorian porch detailing.

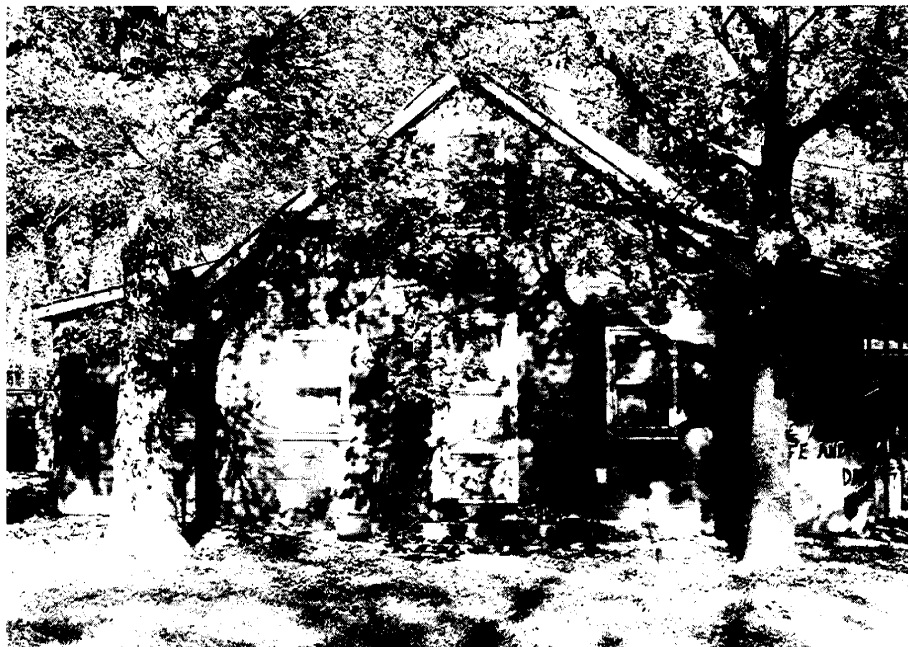
PLATE 31: CRS S-8412
View of north facade of dwelling, looking north.

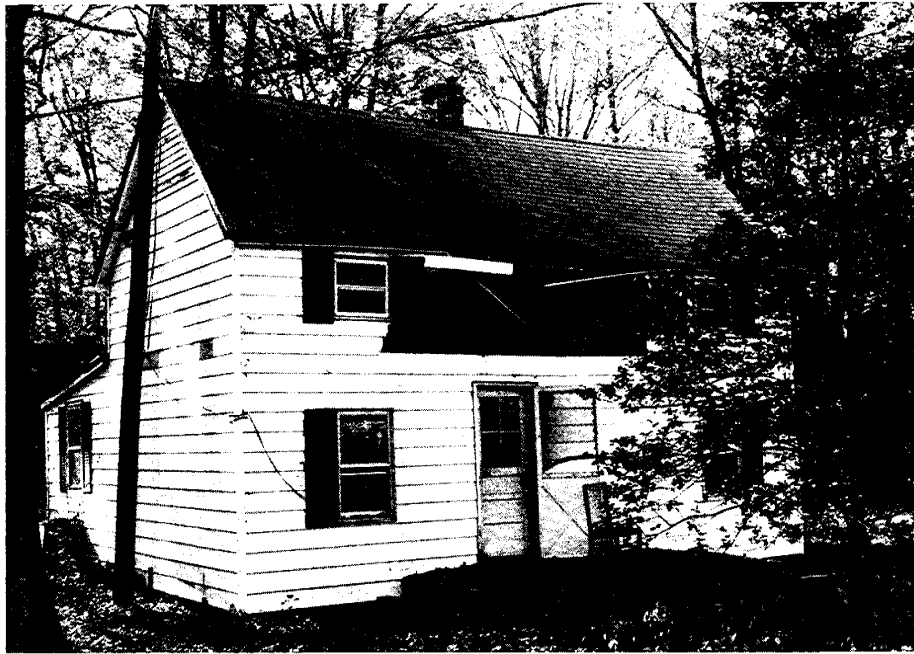
The main house appears to date to the mid to late nineteenth century. The outbuildings seem to be twentieth century additions. Due to a loss of integrity this complex is not eligible. Alterations in the fenestration, a large rear addition, and the overall poor condition of the house, contribute to the lack of integrity. There are better examples of three bay I-houses throughout the corridor.

PLATE 32: CRS S-8413
View of north and east facades of house, looking southwest.
Note heavily altered exterior.

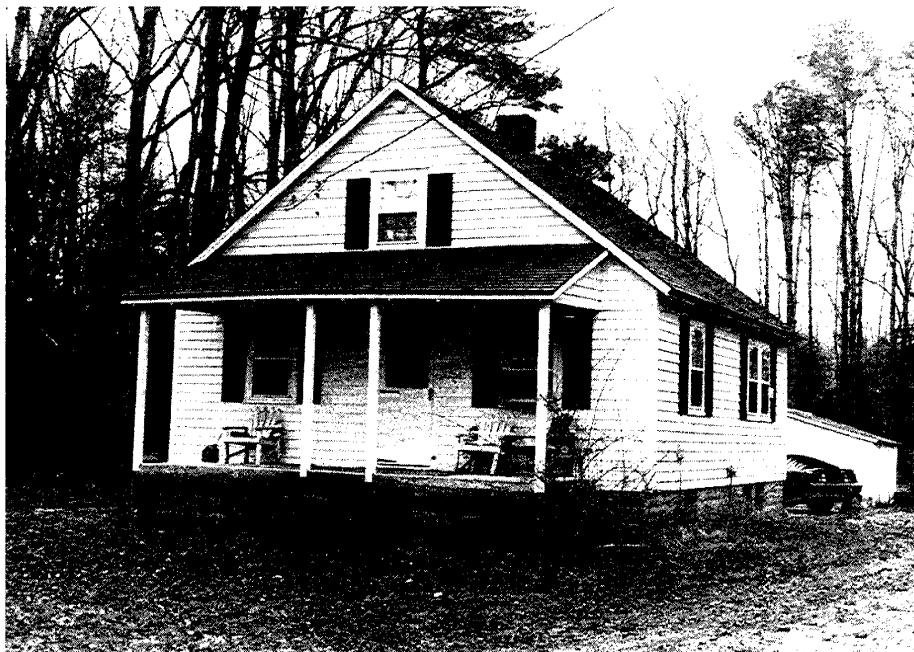
PLATE 33: CRS S-8414
View of north and west facades of house, looking southeast.

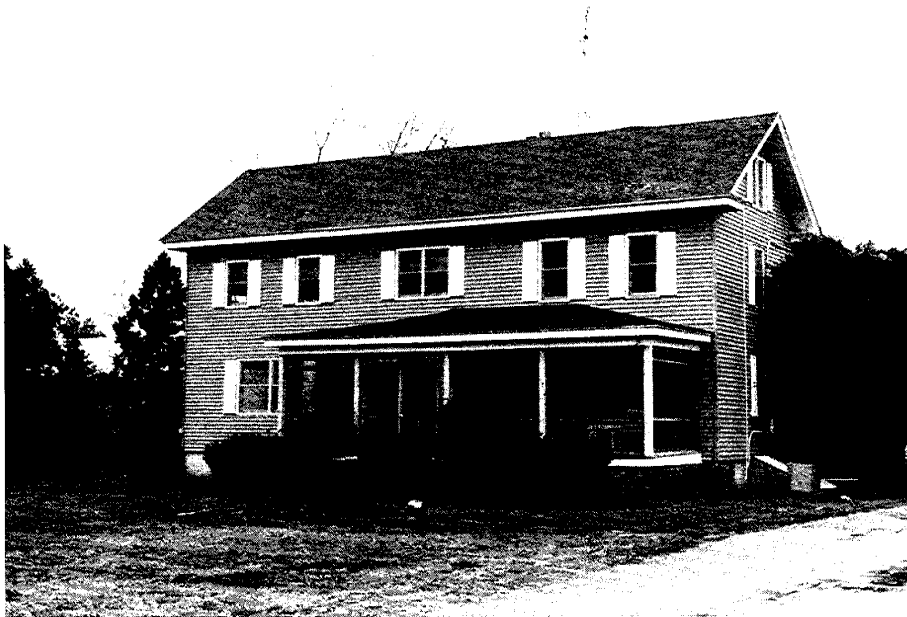
PLATE 34a: CRS S-8415
View of main facade of house, looking west.
Note altered five bay fenestration.

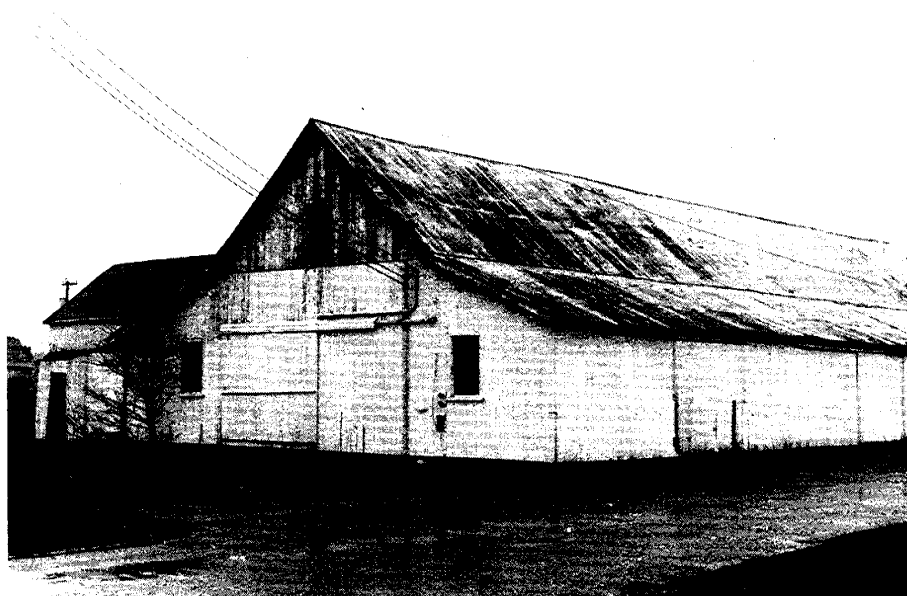
PLATE 34b: CRS S-8415
View of large frame barn on property.
Note frame construction, original windows.

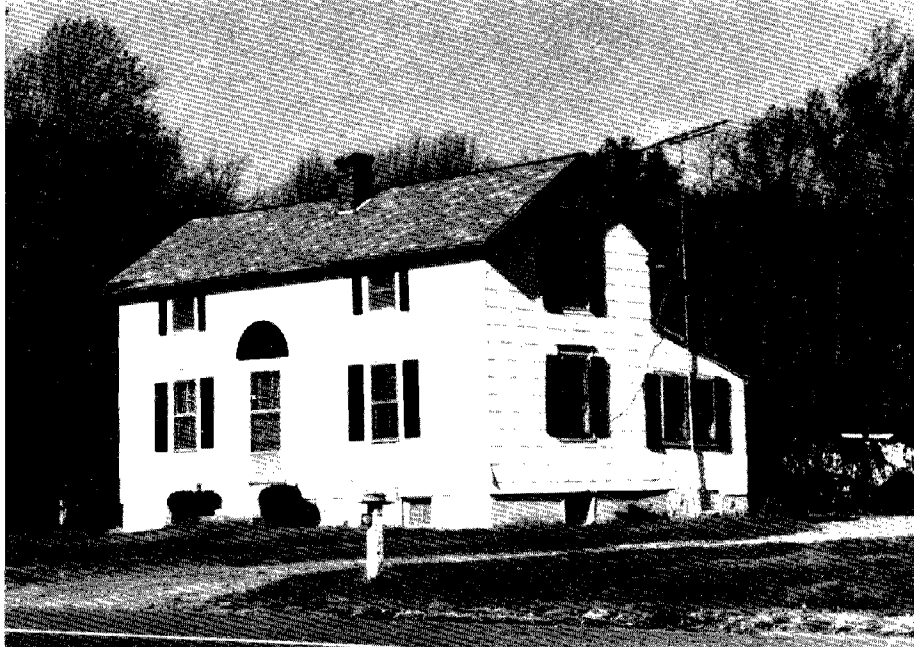
PLATE 35: CRS S-1733
View of north and east facades of house, looking northwest.

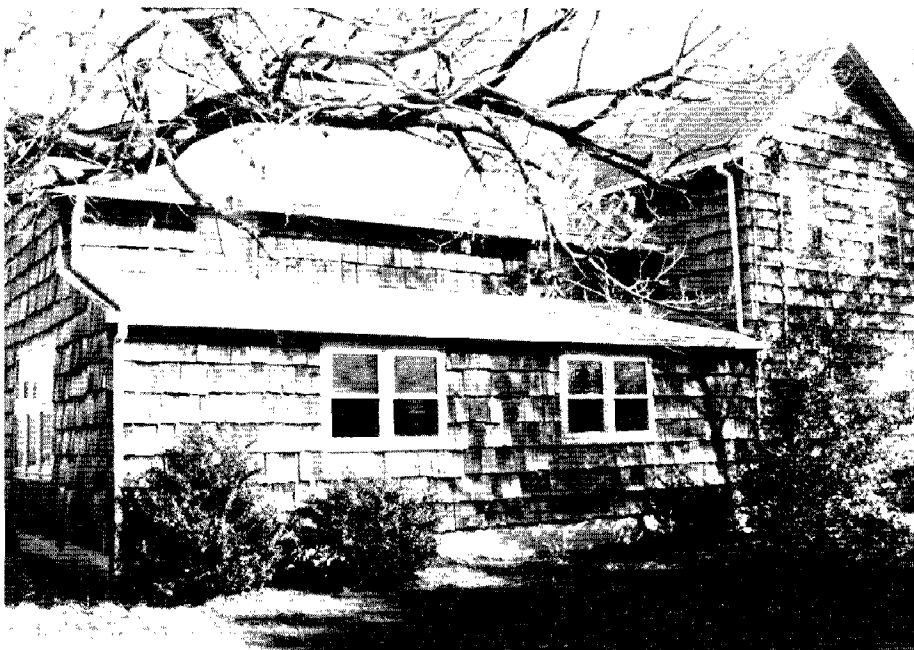
PLATE 36a: CRS S-1734
View of rear of house, with original main section and wing, looking north.

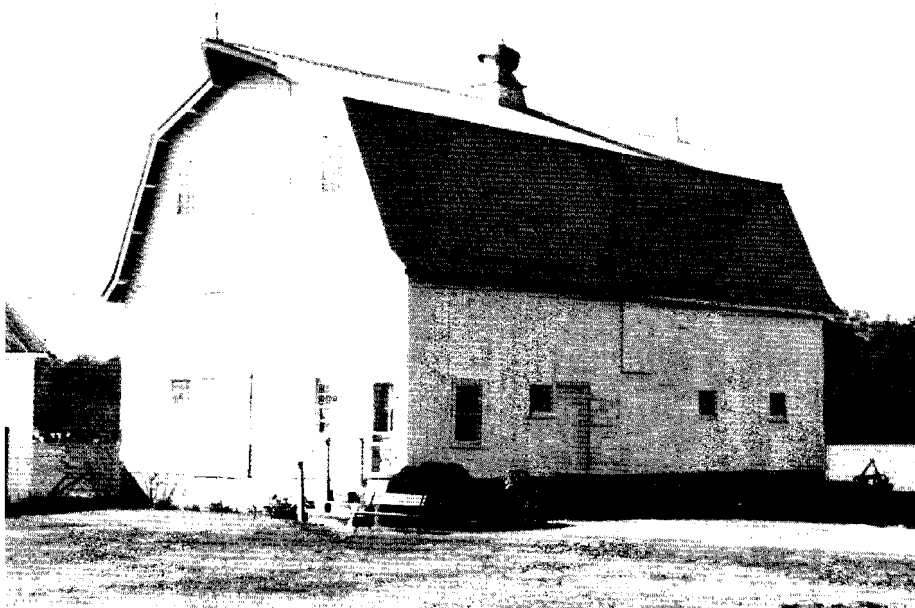
PLATE 36b: CRS S-1734
View of large frame barn located to southwest of house.
Note excellent condition.

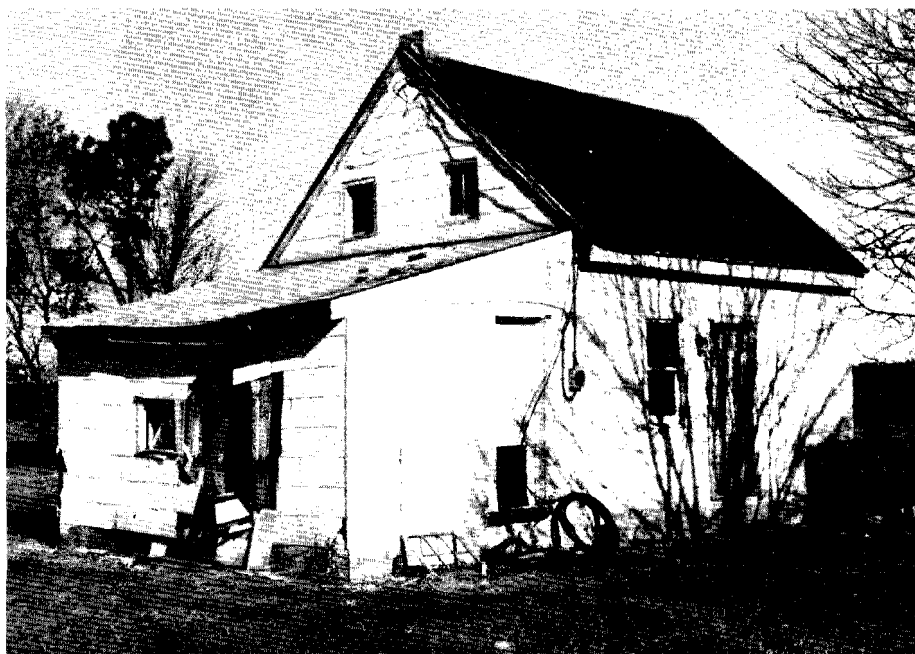
PLATE 37a: CRS S-1664
View of south and east facades of tenant house, looking northwest.
Note early windows at gable end.

This cabin appears to be eligible as part of a Nineteenth Century Tenant Worker Historic District that extends to the north along Road 582. It is significant under the historic context priority of Agriculture 1770-1830 and 1830-1880. Further research is needed to gather more data regarding the type of farming associated with this property and the background of the people who lived and worked on the land. This and other information is needed to fully evaluate this Nineteenth Century Tenant Worker Historic District. The cabin is one of five dwellings comprising the most concentrated collection of tenant houses in the corridor, including CRS S-1731, S-1730, S-1729 and S-1728.

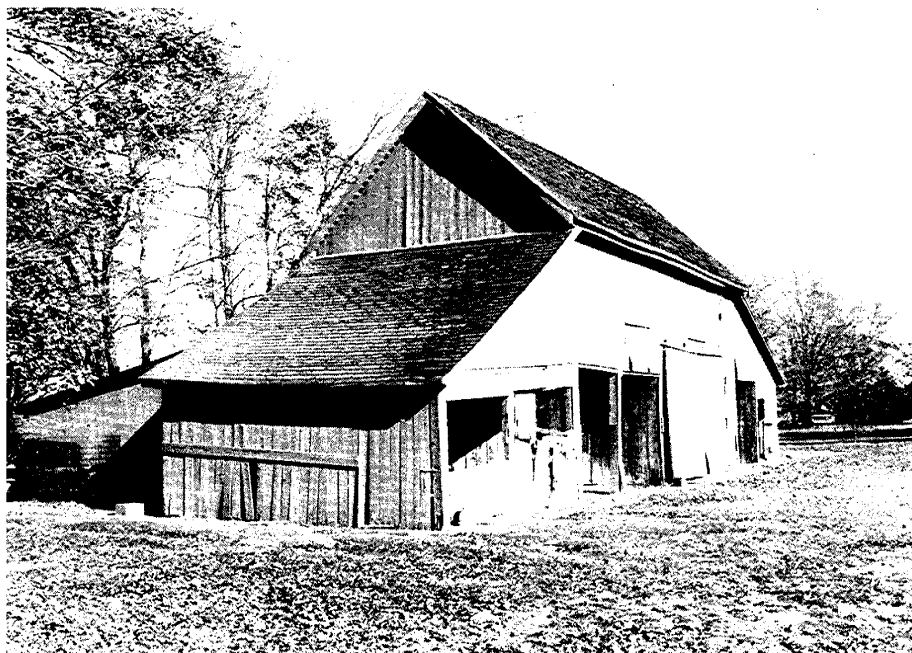
A one and one-half story, frame barn is present to the east of the cabin. This barn is rectangular in plan with shed roofed wings on the north, south and west facades. The structure is clad in green, vertical boarding and has a gable roof sheathed in composition shingles. The shed roofed addition on the west facade of the building has a standing seam, metal roof. The vehicle and animal entrances are on the east facade. The building is in excellent condition and appears to date to the nineteenth century.

PLATE 37b: CRS S-1664
View of south and east facades of frame barn, located to the east of the tenant house.
Note frame construction and excellent condition.
